# Manhole Inspection Summary

Manhole # S07OO1023MH

Insp Date: **1/23/09 9:54 AM**

**Location** Address: **5102 ELMER AVE**

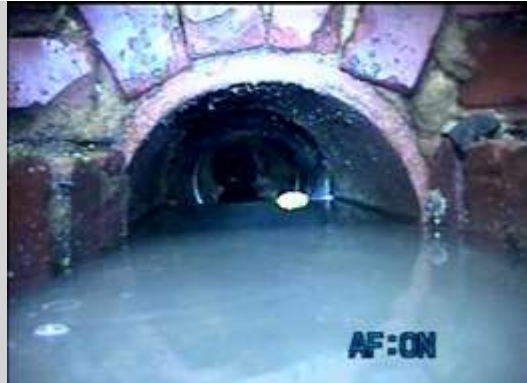
12 O'Clock Outflow

10 in. Circular Gravity Sewer  
Pipe Out @ 12 O'Clock

Pipe Material: **Clay** ☐ Pipe Lined

Invert Depth: **7.54** (ft.) Flow Characteristics: **Slow**

Deposits: ☒ None ☐ Mud ☐ Sludge ☐ Debris ☐ Grease

Infiltration: **None** Pipe Seal Cond: **Sound**

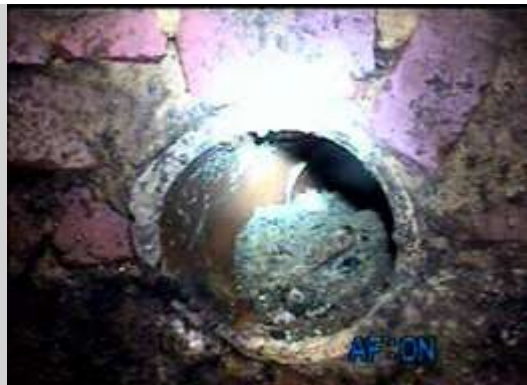
3 O'Clock Inflow

8 in. Circular Gravity Sewer  
Pipe In @ 3 O'Clock

DEBRIS

Deposits: ☐ None ☐ Mud ☐ Sludge ☒ **Debris** ☐ Grease

Silt Depth: **3** (in.) Deposits Extent: **Medium**

Connects To: **Dead End**

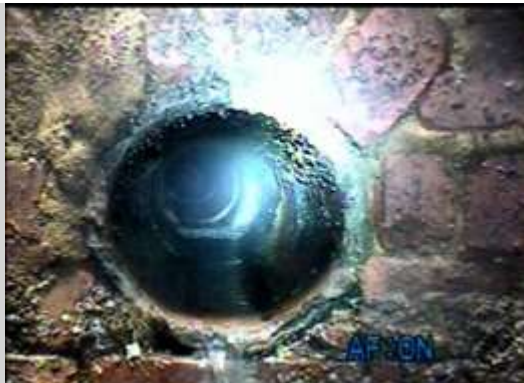
9 O'Clock Inflow

6 in. Circular Gravity Sewer

Pipe In @ 9 O'Clock

Pipe Material: **Clay** ☐ Pipe Lined

Invert Depth: **5.38** (ft.) Flow Characteristics: **Slow**

Infiltration: **None** Pipe Seal Cond: **Sound**

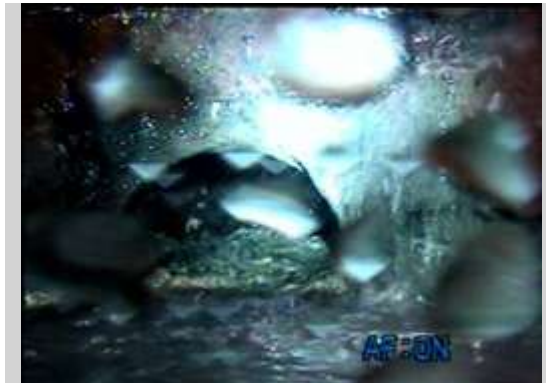
Drop In @ 9 O'Clock

Drop: **Outside Direct**

Inv Depth: **7.18** (ft.)

Drop Condition: **Partly Clogged**

Connects To: **Stub connection / abandoned**
